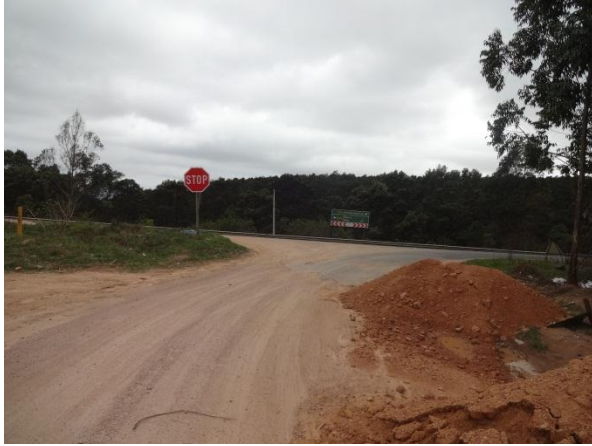
**Picture 1: Taken at the start of the Road 254/1 to be upgraded – intersection with Road P75.**

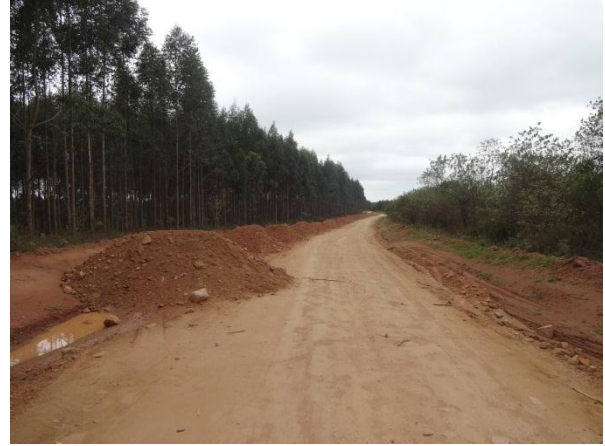
**Picture 2: Taken at the beginning of the road.**

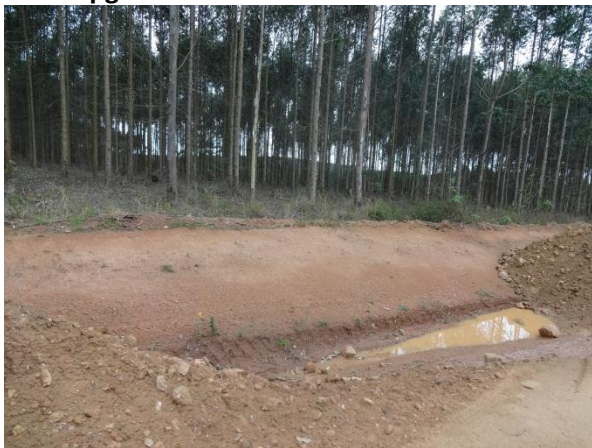
**Picture 3: Road to be upgraded passing through *Eucalyptus* spp. (Gum) tree plantations.**

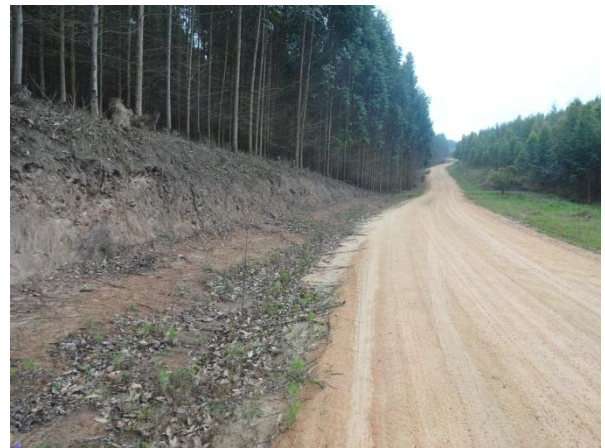
**Picture 4: Road to be upgraded passing through *Eucalyptus* spp. (Gum) tree plantations.**

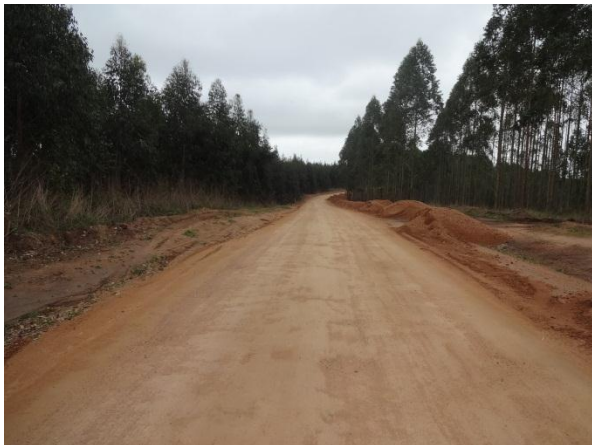
**Picture 5: Taken from the gravel surface condition of the road to be upgraded.**

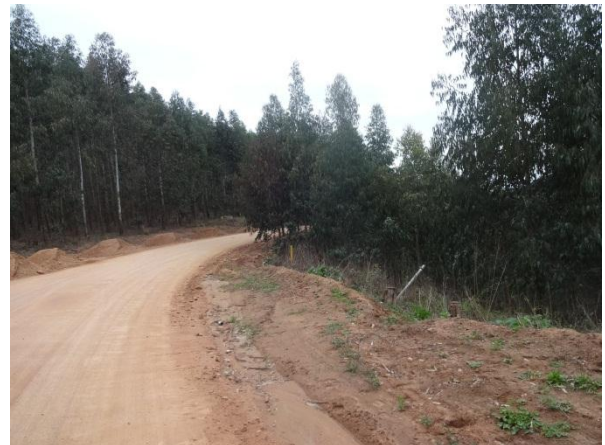
**Picture 6: Taken from the Horizontal curvatures along the first 9 kilometres of the road to be upgraded.**

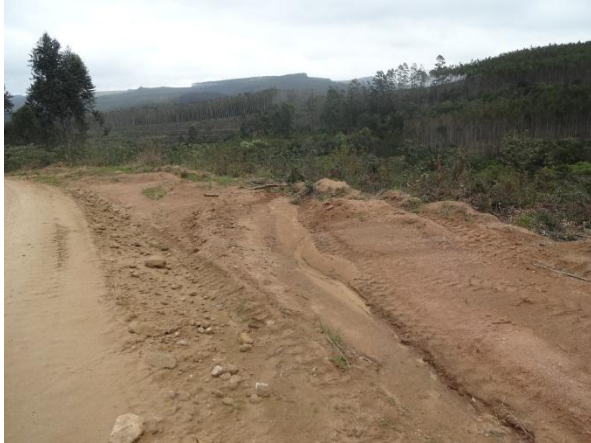
Picture 7: Taken near bend with cut off drain causing erosion to adjacent properties.

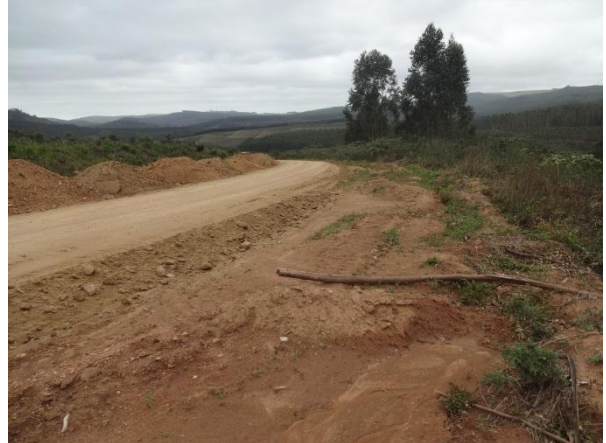
Picture 8: Taken near bend with cut off drain causing erosion to adjacent properties.

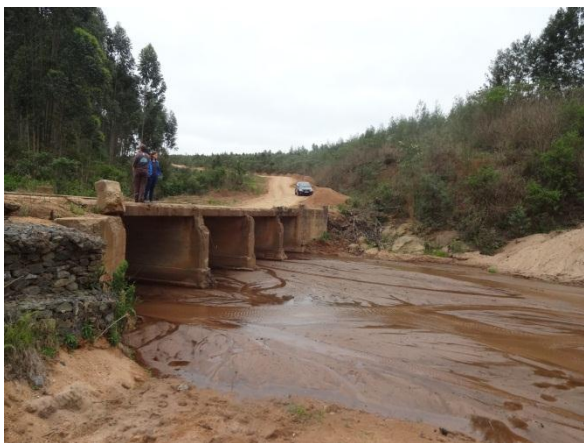
Picture 9: Existing portal culvert at km 3.0 to be upgraded.

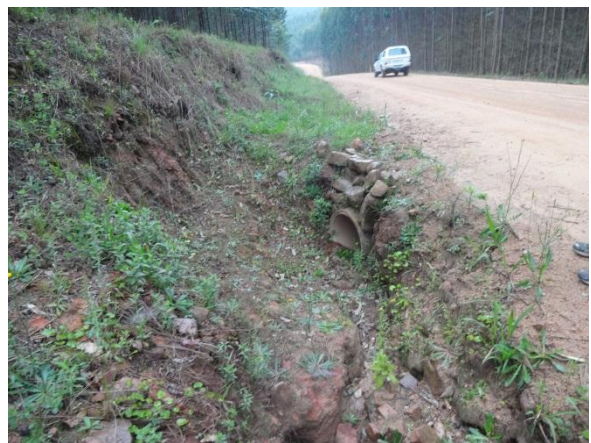
Picture 10: Pipe culvert without outlet causing erosion to adjacent properties.

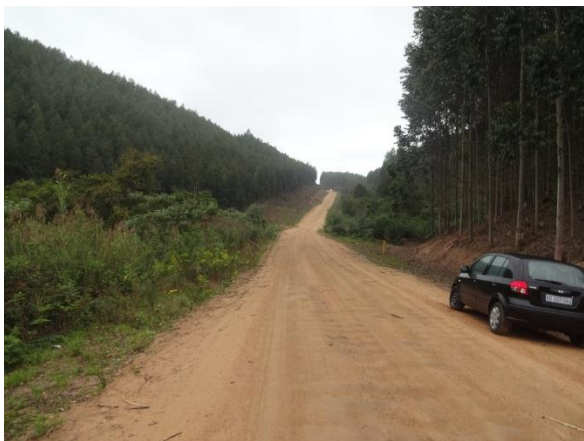
Picture 11: From km 9.0 onwards, mountainous terrain with steep sides and longitudinal slopes (valley lines) and road grades become steep to very steep passing through *Eucalyptus* spp.

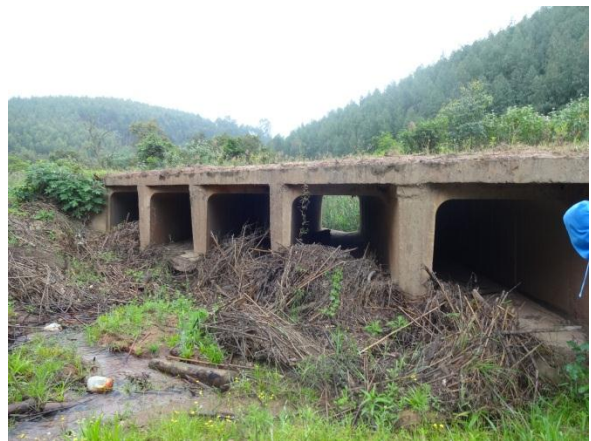
Picture 12: Existing bridge at km 7.4 to be upgraded.
